PHASE I ENVIRONMENTAL SITE ASSESSMENT

**3149 Garden Street Extension/Rt. 89
Town of Seneca Falls, New York**

Project Number: 40212

April 2009

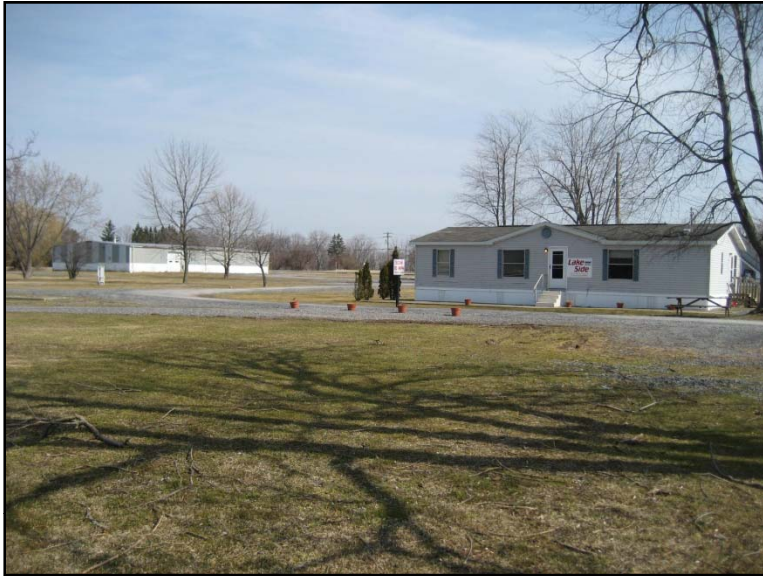
Photograph 1: Entrance to subject Property showing double-wide mobile home and boat repair shop.

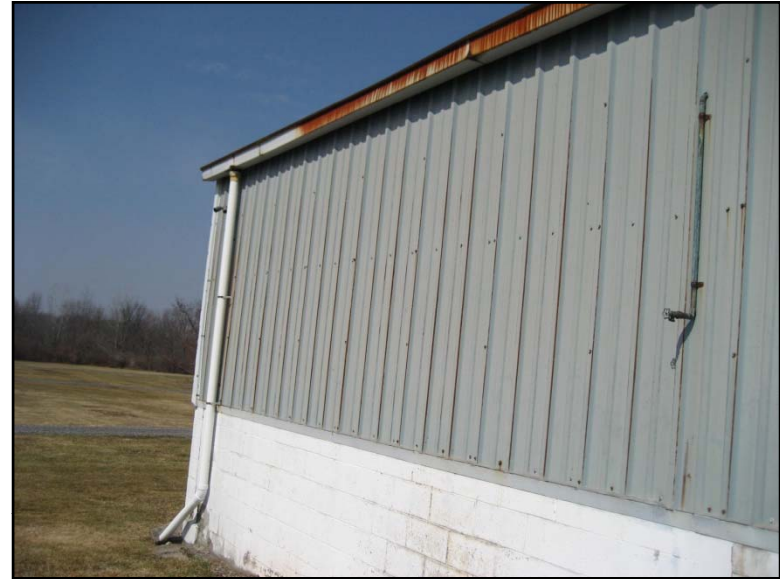
Photograph 2: Boat repair shop exterior showing roof leader drain.

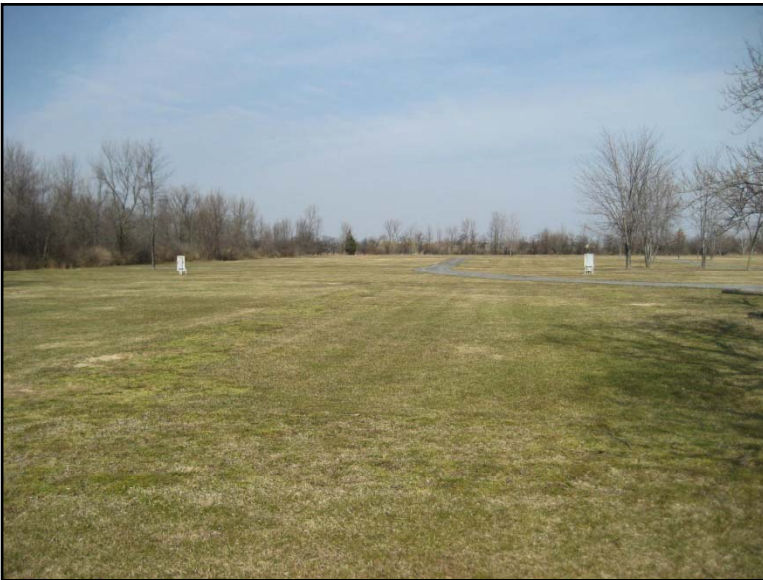
Photograph 3: Campground portion of the subject Property.

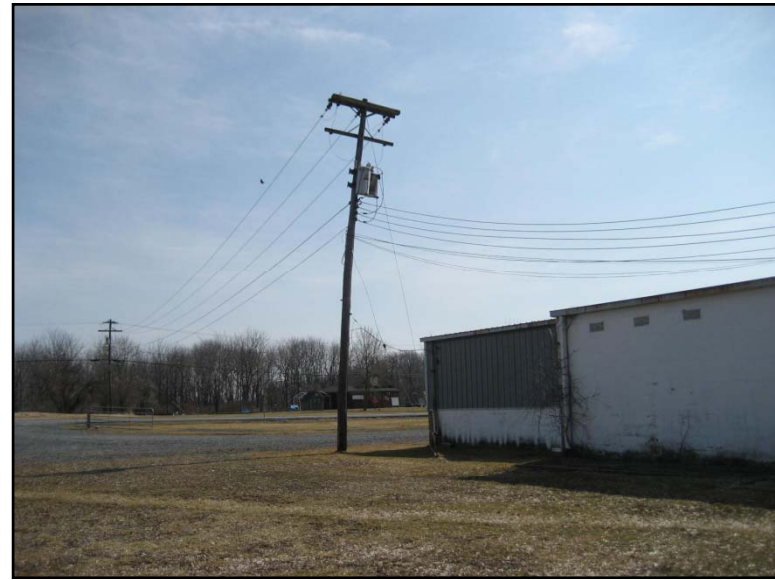
Prior to 1979, polychlorinated biphenyls (PCBs) were widely used for their cooling properties in electrical equipment such as transformers, capacitors, switches and voltage regulators. Two pole-mounted transformers were located on a utility pole adjacent to the northeast corner of the former boat maintenance building. The age of the transformers was unknown and there is a potential for the transformers to have utilized PCB-containing fluids. Any release of oil due to transformer failure would spill to the underlying ground surface. There were no areas of stained soil or stressed vegetation beneath the transformers.

Photograph 4: Pole-type transformer on subject property.

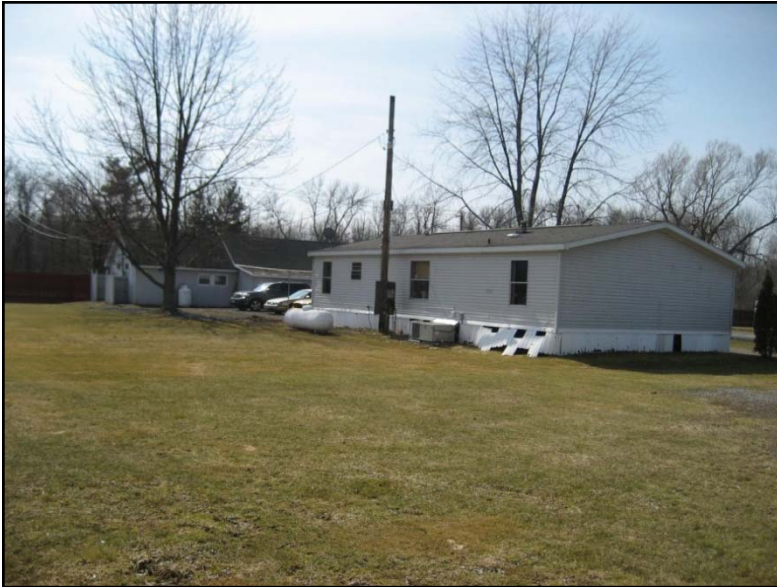
The Cayuga County Clerk's Office reports that the double-wide mobile home used as Lakeside Enterprises of the Cayuga Nation offices was constructed in 1993 when ACM were rarely used in construction. The one-story and the vacant wood construction building on Seneca County Tax Map 36-1-48.2 was reported to have been constructed in 1980 and may have utilized ACM. The structure on Seneca County Tax Map No. 36-1-48.1 included a former boat repair shop constructed in 1965, during the time that ACMs were used in construction. Suspect ACMs observed during the site visit suspended ceiling tiles, pipe insulation, vinyl floor tiles beneath carpeting, and window caulking. Additional suspect ACMs may be present within pipe chases, behind walls, or in other hidden locations.

Photograph 5: Building exteriors of the double-wide mobile home and the vacant wooden construction building.

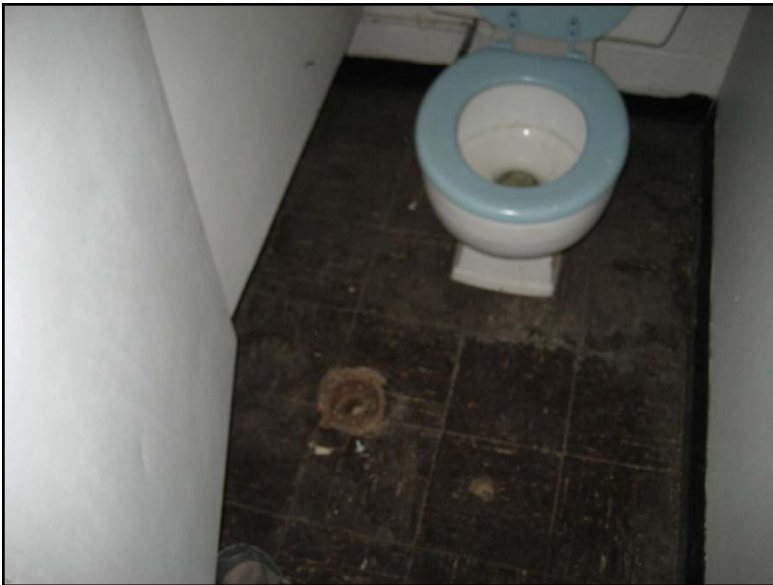
Photograph 6: Bathroom with tile floor.

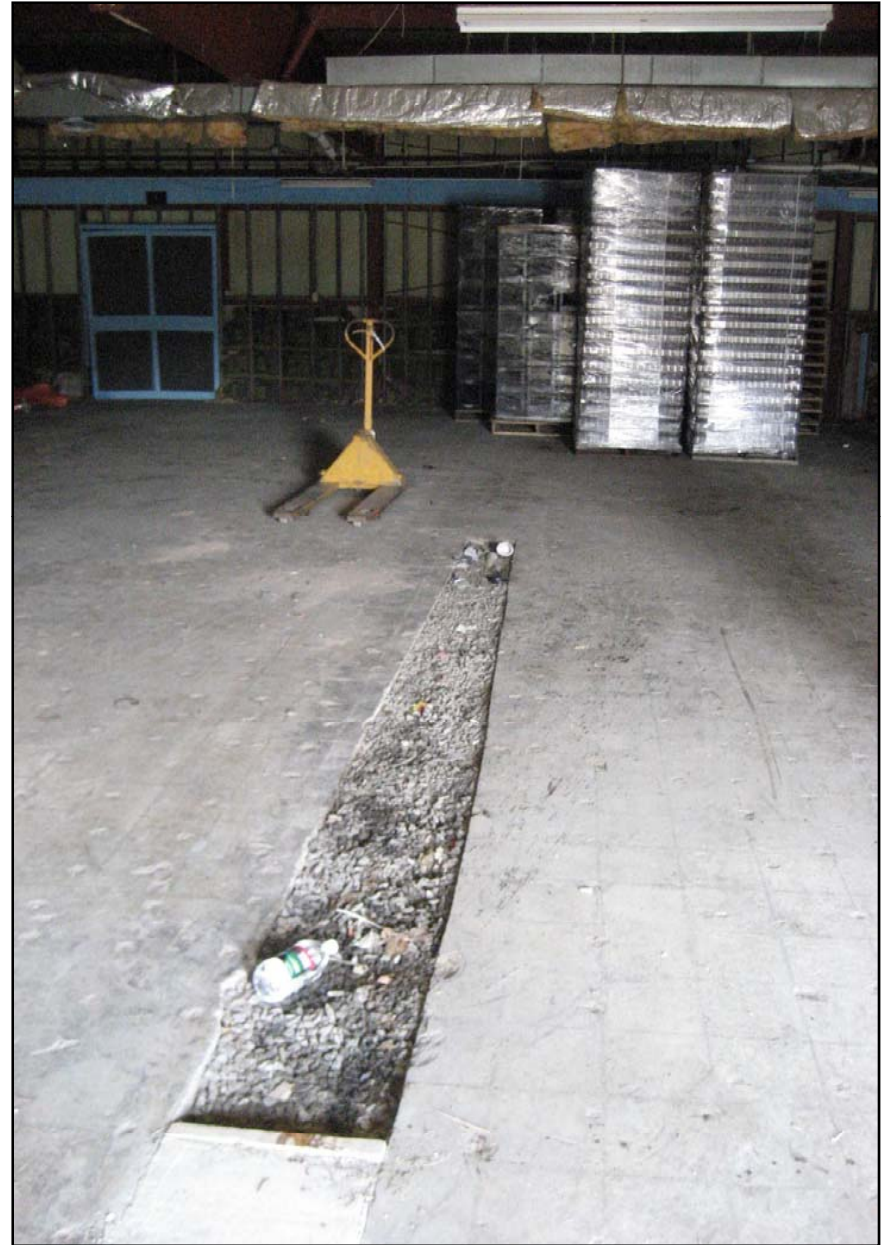
- The subject property was formerly used as a boat repair shop. Repair activities are likely to have included boat motor tune-ups, fluid (gasoline, motor oil, and gear oil) changes, boat painting, and general maintenance. Improper storage, handling, or dumping of raw or waste fluids during maintenance activities may have resulted in releases to the soil or groundwater at the subject property. The repair shop building contained a floor trench in the maintenance area that was filled with gravel. There was no information indicating if the trench was used as a collection pit or if it contained a drain to transfer fluids outside the building. There were no areas of staining observed on the floor or outside the building.

Photograph 7: Interior of the boat repair shop, including thermal system insulation, tile flooring and trench drain.

- Although there was no contamination documented during the investigation, the only way to verify if any boat maintenance or repair activities have resulted in a release of contamination to soil or groundwater at the site soil is to complete a subsurface investigation. If future on-site development requires subsurface disturbance, soil would need to be tested and managed in accordance with applicable local, state and federal requirements. If any unforeseen fuel oil tanks or evidence of contaminated soil (stains or odors) are encountered during site development, these materials (and all other materials requiring off-site disposal) should be disposed of in accordance with applicable federal, state and local regulations.
