PHASE I ENVIRONMENTAL SITE ASSESSMENT

**Vacant Parcel, High Street
Town of Springport, New York**

Project Number: 40212

April 2009

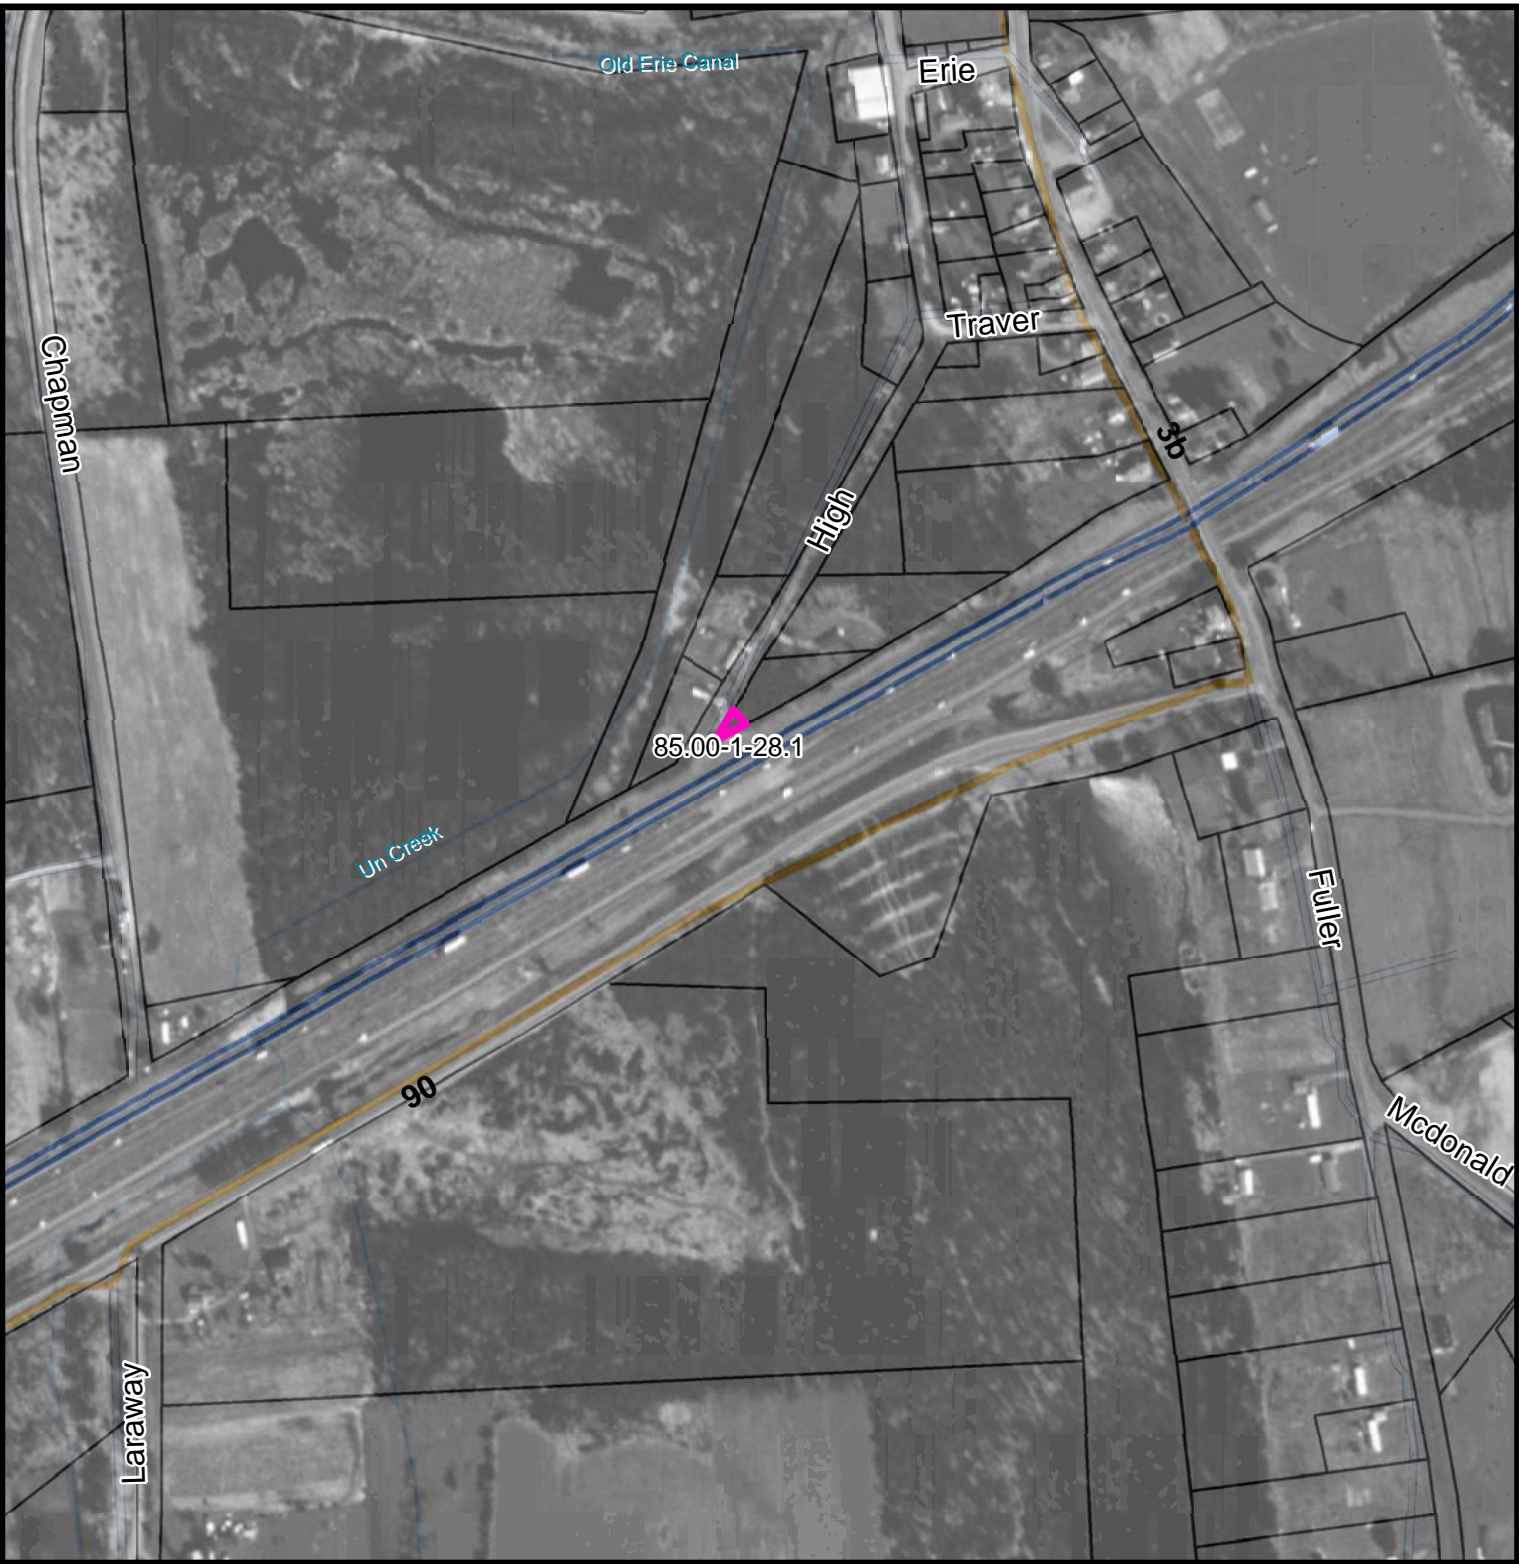
<p>HIGH STREET MONTEZUMA, NEW YORK</p>	 	<p>DATE 4.12.09</p>
<p>SITE PLAN DETAIL</p>	<p>Environmental Consultants 440 Park Avenue South, New York, N.Y. 10016</p>	<p>PROJECT No. 40212</p> <p>FIGURE 2</p>

Source: NYS Clearing House
Aerial Photo 2007

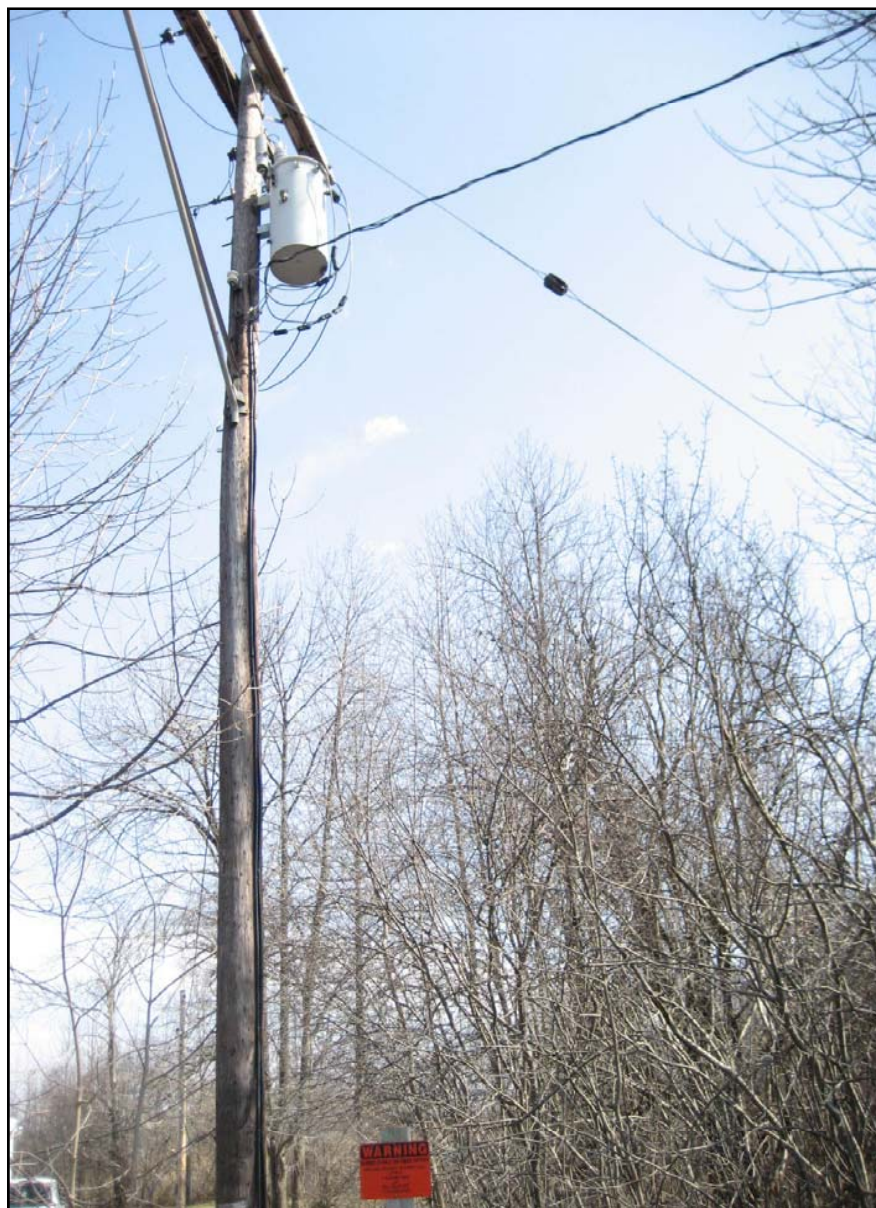
- One pole-mounted transformer was located on a utility pole adjacent to the northwest corner of the subject Property. There is a potential for the transformers to have utilized PCB-containing fluids. Any release of oil due to transformer failure would spill to the underlying ground surface. There were no areas of stained soil or stressed vegetation beneath the transformers.

Prior to 1979, polychlorinated biphenyls (PCBs) were widely used for their cooling properties in electrical equipment such as transformers, capacitors, switches and voltage regulators. One pole-mounted transformer was located on a utility pole adjacent to the northwest corner of the subject Property. There is a potential for the transformers to have utilized PCB-containing fluids. Any release of oil due to transformer failure would spill to the underlying ground surface. There were no areas of stained soil or stressed vegetation beneath the transformers.

Photograph 1: Pole-type transformer along wooded area.

- A subsurface (Phase II) investigation is not recommended at this time, however if future on-site development requires subsurface disturbance, soil (and groundwater if dewatering were to be required) would need to be managed in accordance with applicable local, state and federal requirements. If any unforeseen fuel oil tanks or evidence of contaminated soil (stains or odors) are encountered during site development, these materials (and all other materials requiring off-site disposal) should be disposed of in accordance with applicable federal, state and local regulations.
- Radon levels would need to be tested in accordance with applicable regulations for any future on-site development.

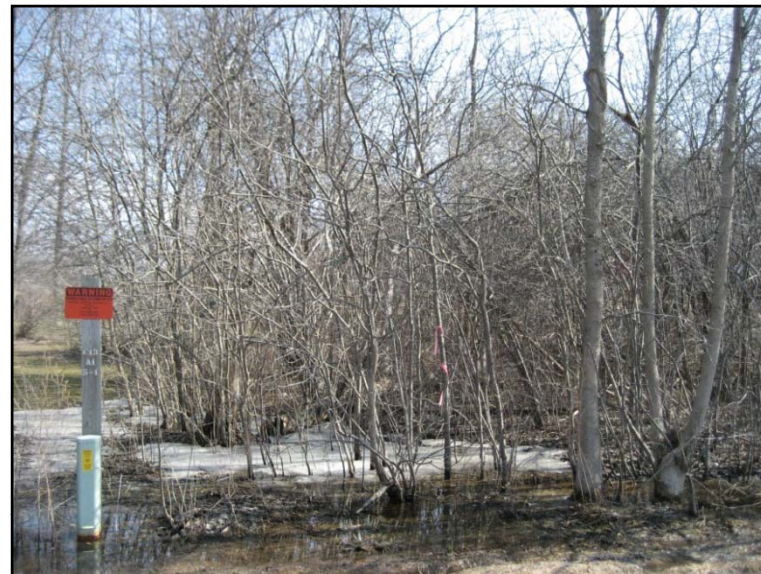
Photograph 2: Utility box near transformer in wooded area.

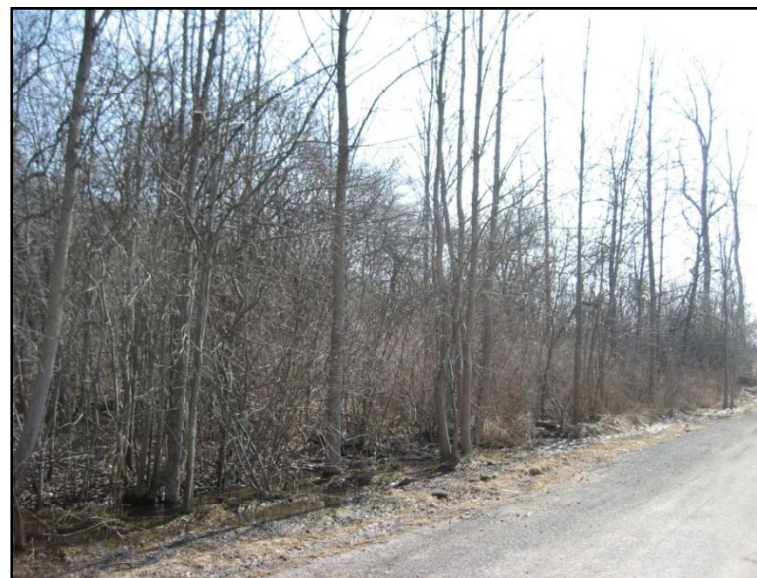
Photograph 3: Roadway along wooded parcel.
